HISTORIC STRUCTURE REPORT

THE PARSON CAPEN HOUSE

The Topsfield Historical Society
Topsfield, Massachusetts

APRIL 1 2002

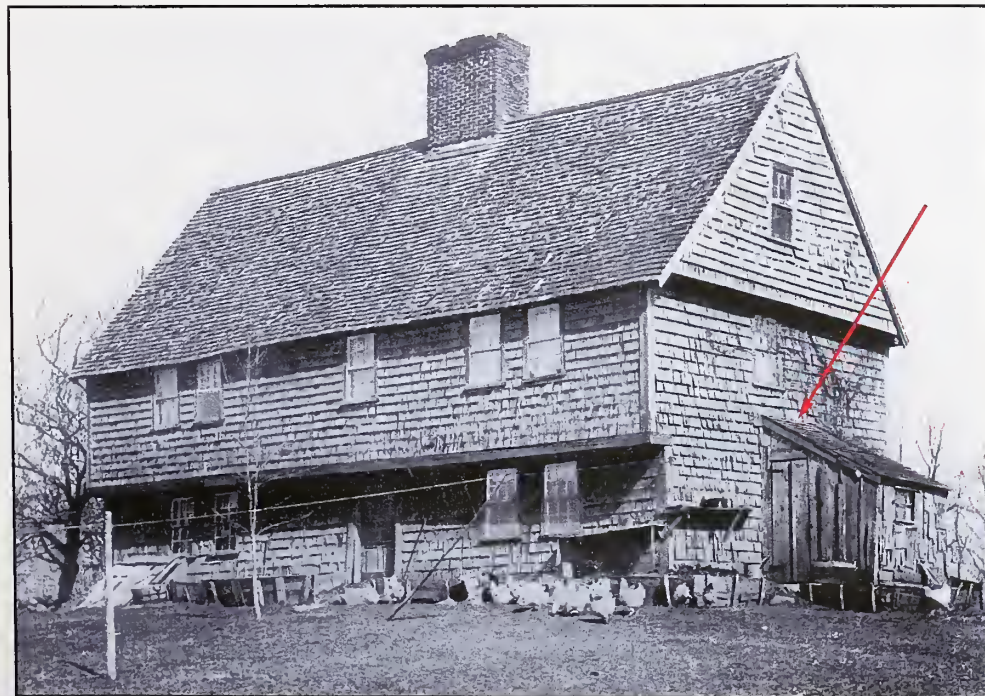
1.4: C. 1880's photo of the house showing the east and south facades. This may be a little earlier than photo 1.1 above, as the chimney is in a little better condition. The leanto shack serves as a vestibule for the 18th century west entry door. Defective flashing and roofing at its junction to the gable wall (arrow) were likely the cause of the extensive decay in the east end girt still visible in the Hall.

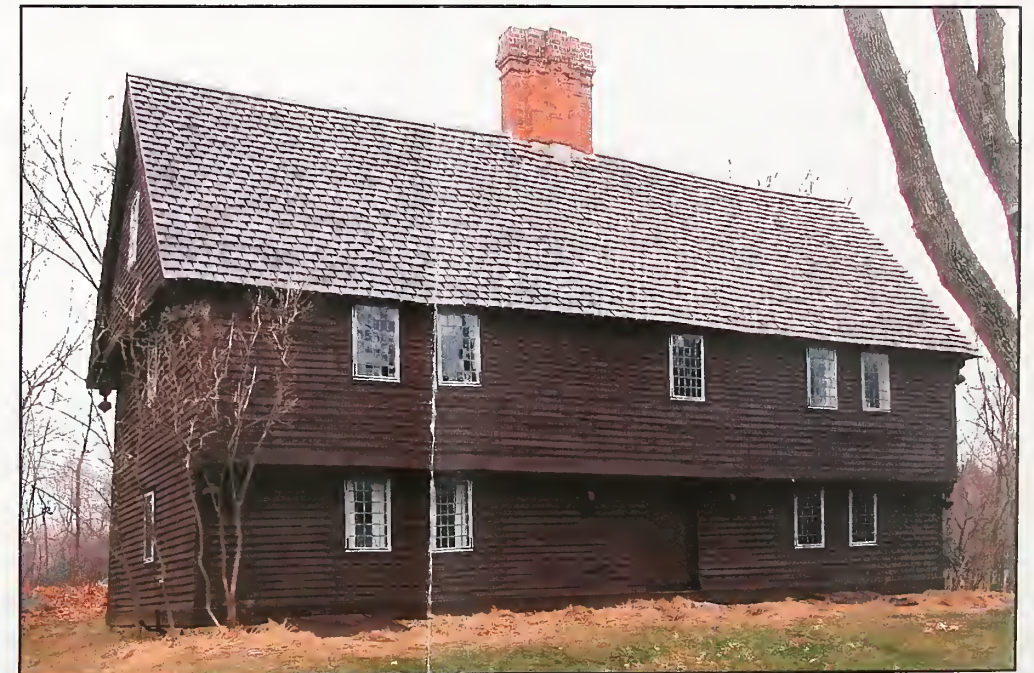
1.6: Current appearance of the front and west facades of the house. The current treatment of dark brown opaque stain has been used since the 1970's. The wood shake roof has a rougher texture than the wood shingles that were used historically.

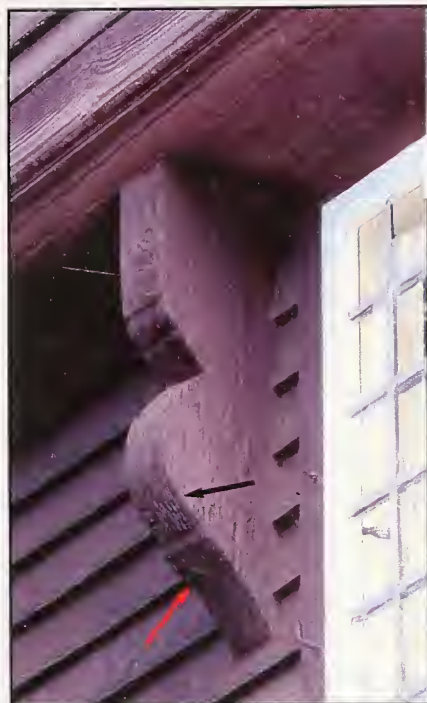
2.1: Existing bracket at west gable attic overhang. This specific bracket can be documented back to the 1880's in historic photographs, and is therefore probably original. The east gable bracket is c. 1913 based on this one.

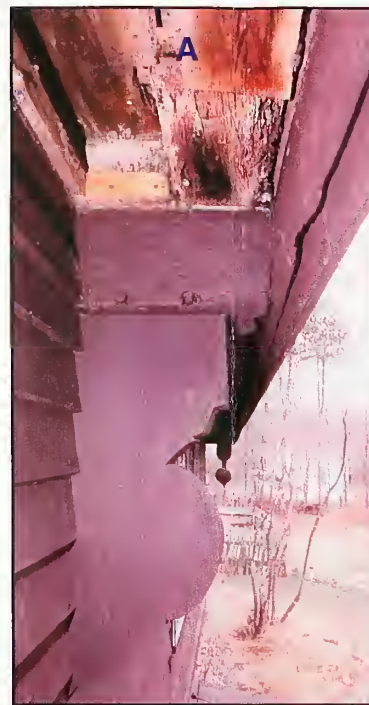
2.3: 1913 Bracket at front overhang under east chimney girt. The overhanging girt is visible at the top of the photo after the removal of the modern soffit; it shows an old repair at A.

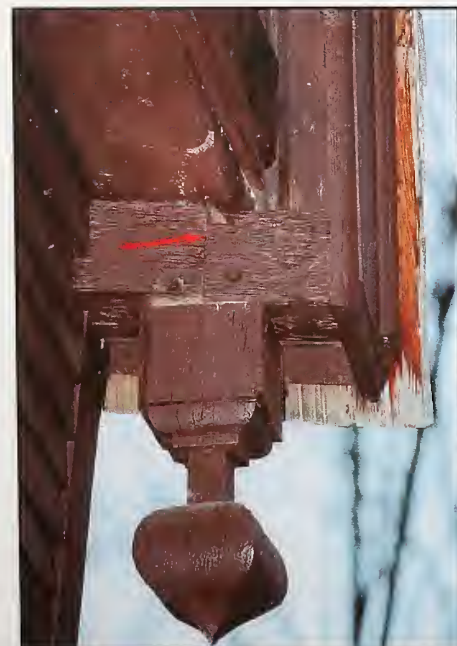
2.6: Existing pendent drop at the northeast corner of the attic gable overhang. Dow's added extension to the rear plate to support the verge board and drop is clearly visible (arrow).

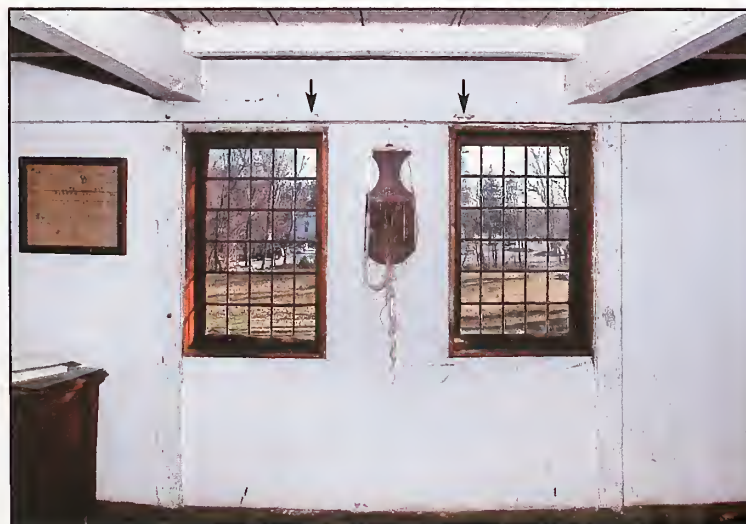
The surviving first floor studs that appear to have served as window jambs in the parlor are deeper and wider than the other wall studs and protrude into the room slightly beyond the line of the original plaster (Fig. 3.4). The window studs in the hall have been replaced or altered, but four unaltered ones remain concealed by the furred out plaster walls of the hall chamber. These are identical to the parlor studs with clear evidence that they originally protruded beyond the face of the finish plaster (Fig. 3.3, 5.4). The use of this unusual feature on both sides of the house suggests the house was built at one time.

3.4: Front wall of parlor showing the two remaining oversized studs that project beyond the plaster face. The pins for the two missing original studs are marked by arrows but do not show in the photo because of the white paint.

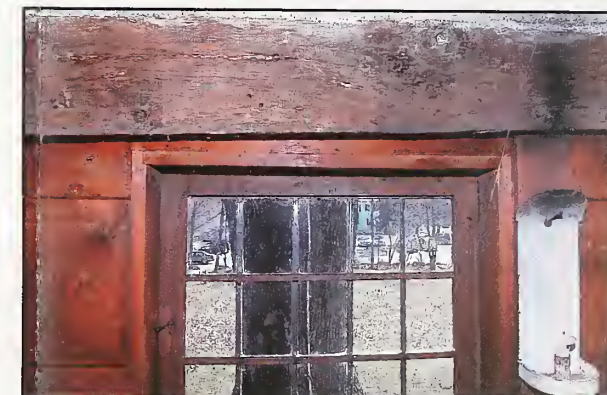
3.6: Hall front window showing location of original pins in girt in relation to the current window frame. The right hand stud had been cut back to hide it behind the plaster and accommodate the replacement window trim in the 18th or 19th century. Dow pieced it out to mimic the studs still visible in the parlor. Removal of the exterior sheathing at the pier to the left of this window revealed that the existing stud used to frame the left side of this window is fastened to an open gain cut in the face of the girt with a wrought nail, and thus likely dates to the 18th century.

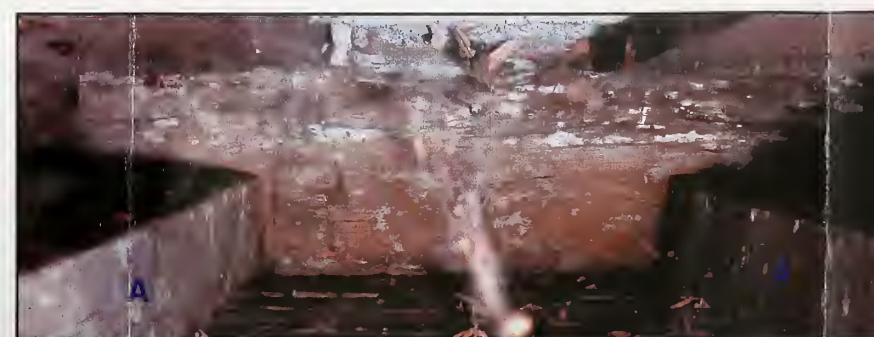
3.8: Hall chamber looking up at the underside of the roof plate between the 18th century window studs which are marked "A". There is no visible evidence that an original sash might have been in this bay. The tan stains are residue of brick and clay nogging, and the white line is whitewash residue at the face of the original plaster finish over the 3" thick nogging.

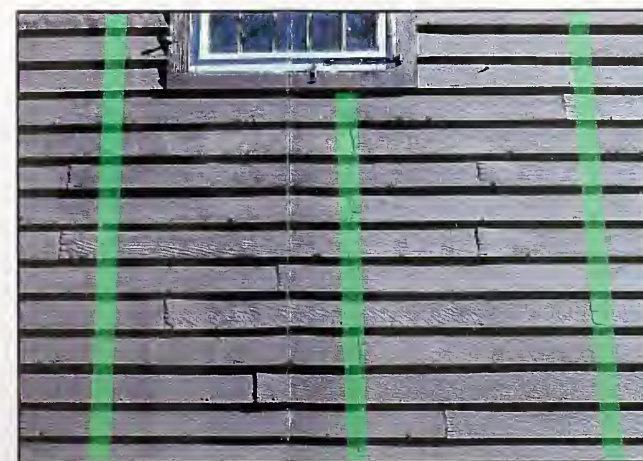
6.5: Oak clapboards installed by Dow in 1913 on the west gable showing their random alignment relative to the placement of studs, which are marked by the green lines. As he was applying them over the sheathing boards, he inadvertently followed 18th century practice of nailing randomly to the sheathing rather than aligning the ends over the studs.

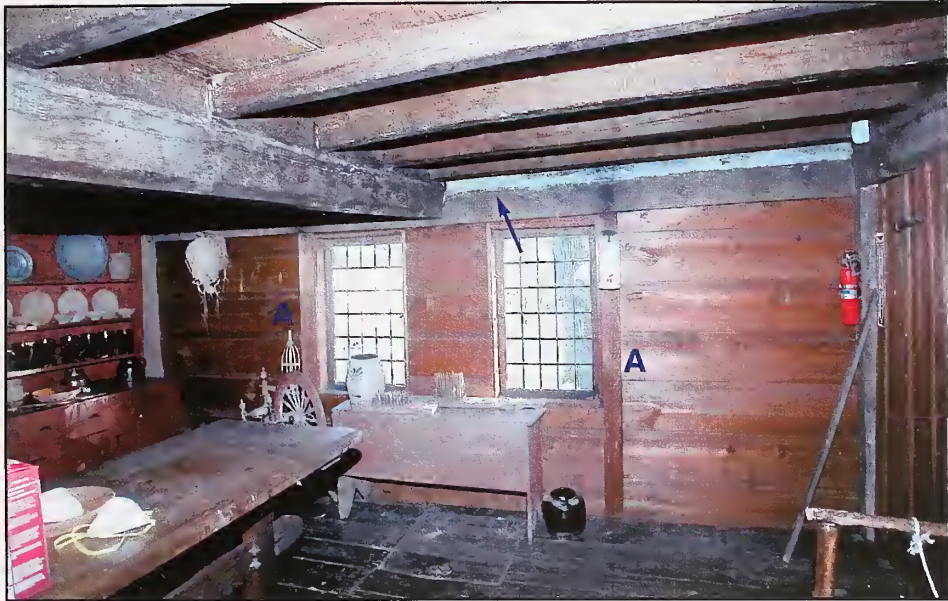
8.1: Front (south) wall. Piecing out of window studs (A) by Dow mimics the existing original studs in the Parlor (see 3.4). The low headroom under the summer beam was not intentional and is due to substantial settlement of the frame from long past deterioration. The summer beam is 6" lower at the rear wall than at the front wall, and several inches lower at the front wall relative to the chimney girt at the entry hall door. The white material above the front girt is plaster over the brick nogging filling the space between the top of the girt and the ceiling boards. The hard white plaster dates to Dow, but a small portion of original clay plaster remains exposed to the right of the summer beam (arrow). This is a typical first period detail that also present over the girts in the parlor and stairhall.

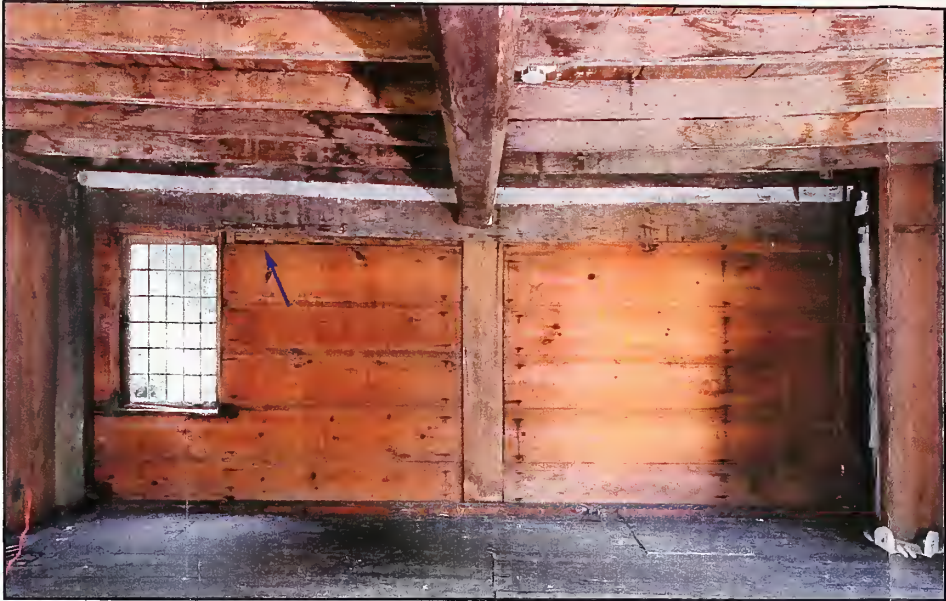
8.2: Rear (north) wall of hall. The post under the summer beam is a cosmetic board added by Dow (see 8.3). The rear girt sags downwards substantially to a low point at the summer beam due to 19th century sill deterioration. The new conventional studs and header used by Dow to reframe this wall are visible to the right of the window (arrow). The stains on the 1913 wall sheathing are from past leaks in the plumbing or the heating pipes overhead. The window is in an 18/19th century opening in the probable location of an original brace, or possibly a rear door (Dow's framing obscures any remaining evidence).

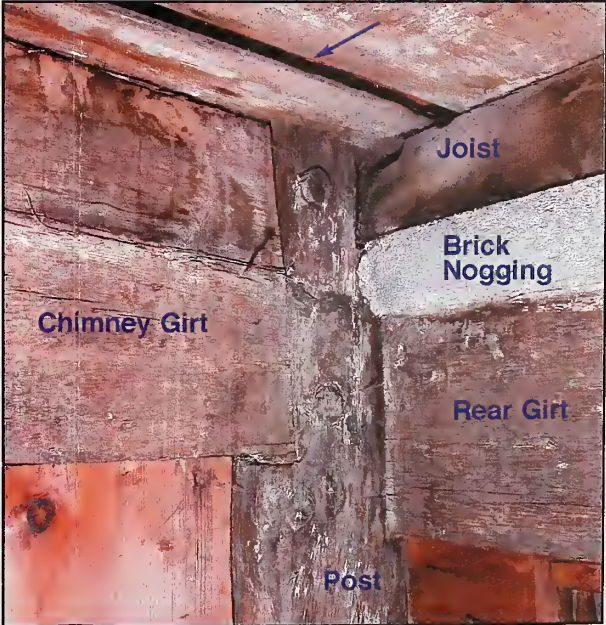
8.5: Northwest corner post. The rear girt and joist above it have pulled out of their mortises about 1". The joint between the floorboards above (arrow) reflects similar past movement. The joist is probably bearing on the brick nogging behind the plaster below it. The detailing of the joint of the chimney girt to the post is the same at all four rear posts.

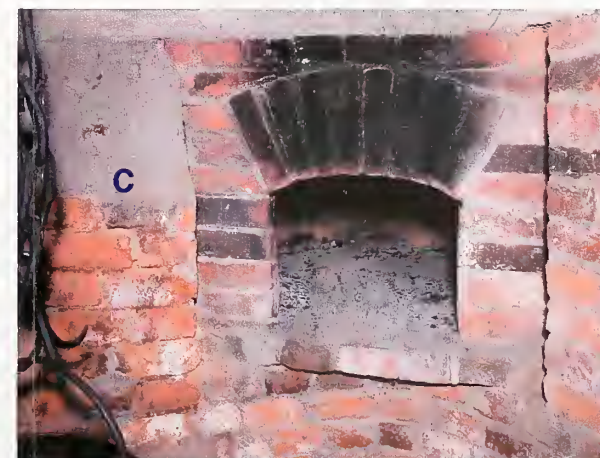
9.5: Bake oven as reconstructed by Dow following the evidence visible noted in 9.2 above. The pier to the left of the oven (marked C) retains its original brick and some exposed early clay mortar. Note that Dow used a grey Portland cement mortar for all his rebuilding and repair work. Although this makes it easy to distinguish his work from the original clay mortar, it is too strong in relation to the weak original mortar and brick, and visually unattractive. More recent repairs have also been done with grey portland cement.

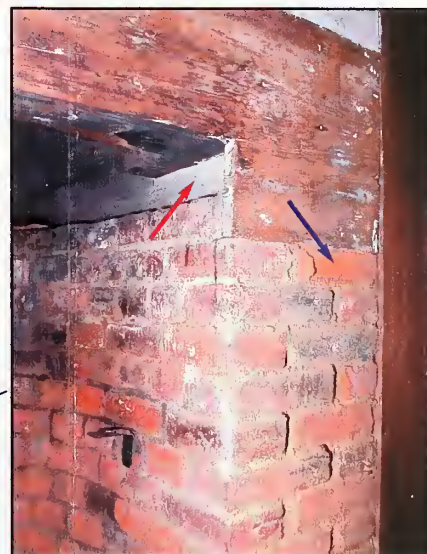
12.4: Original tan colored clay mortar indicates this pier is the original construction. The cement parging above the brick (red arrow) is modern. The spalled (i.e., eroded) brick face (arrow) is due to a combination of the soft underburnt early brick and dampness rising up in the masonry from the basement. Unfortunately the spalling is nearly impossible to stop, but its progress can be slowed by drying out the basement.

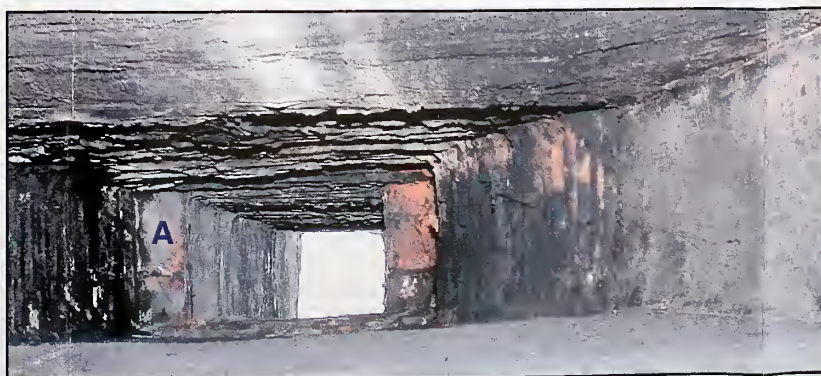
12.6: Interior of chimney stack. Cement parging has been applied over the brick well up into the second floor, probably in 1972. The unparged soot covered bricks are in the attic, while the section above the brick marked A is above the roof line and was rebuilt in 1913.

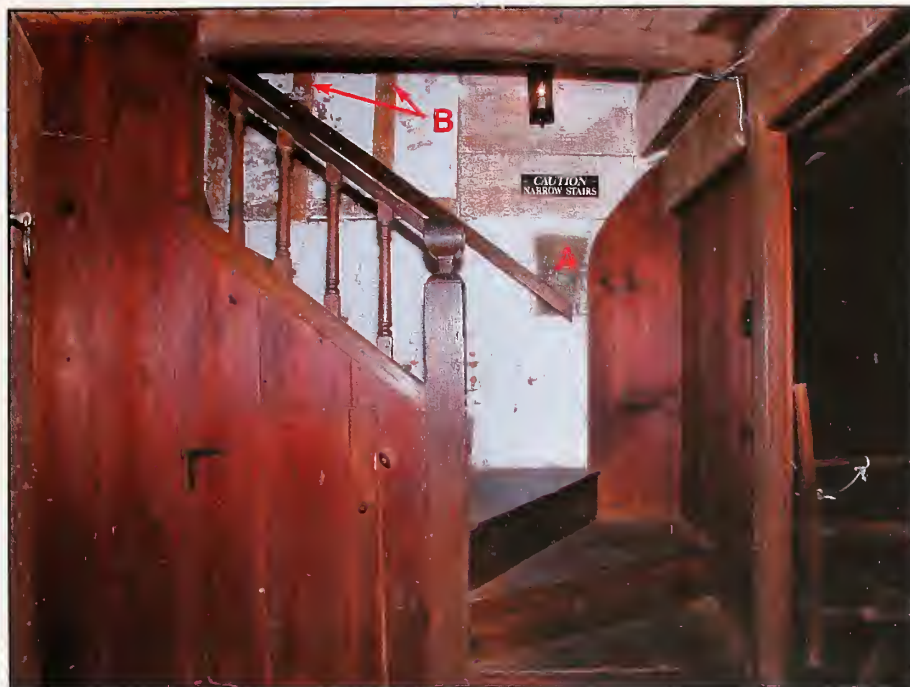
13.1: Current appearance of the stair. Remaining original elements are limited to the the newel post, balusters with top and bottom rails, the mantel tree from the hall fireplace lintel (A), the chimney brick, and the framing set against the brick (B) to support the second level stair above. The stair treads and risers were reconfigured in 1913, and all the board sheathing also dates to 1913.

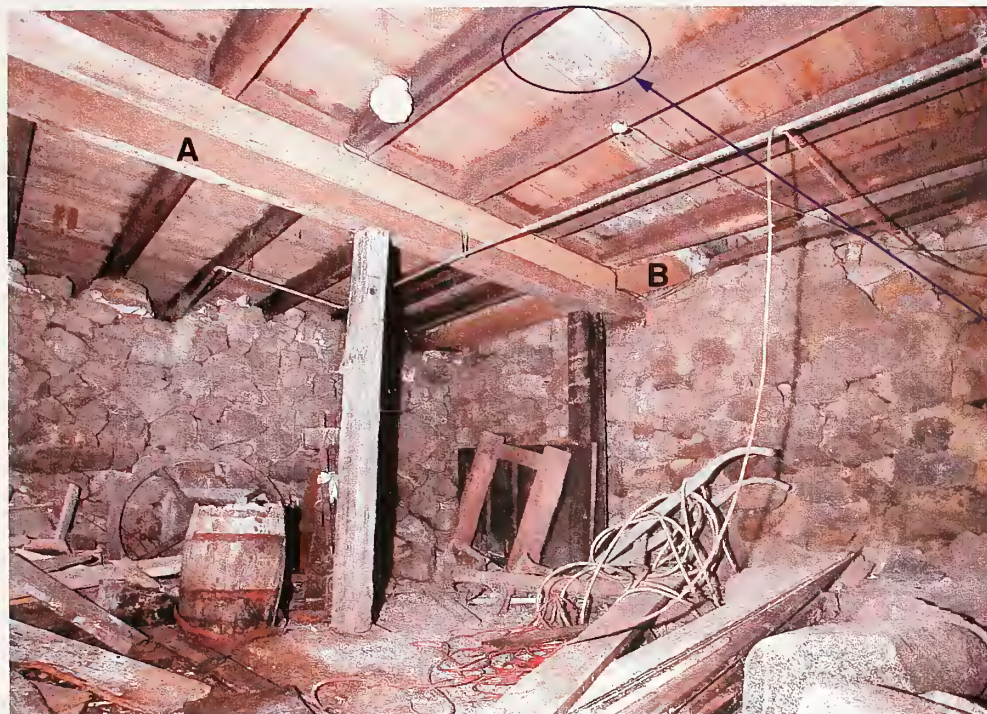
16.1: West (parlor) basement looking towards chimney foundation and north walls. Summer beam marked A is original with modern ledgers added to reinforce the joist support. Posts are modern additions. The beam marked B is an early timber being used to support the outer portion of the fireplace hearth above. Whether it is a piece reused by Dow or an original timber is not known. Most of the joists visible in the picture are replacements that have still newer members sistered to them. Subflooring includes 19th century sheathing reused by Dow from former partitions. The jumble of materials on the dirt floor need to be sorted with collections materials and old wood fragments from the house placed in proper storage, and the other materials thrown out.

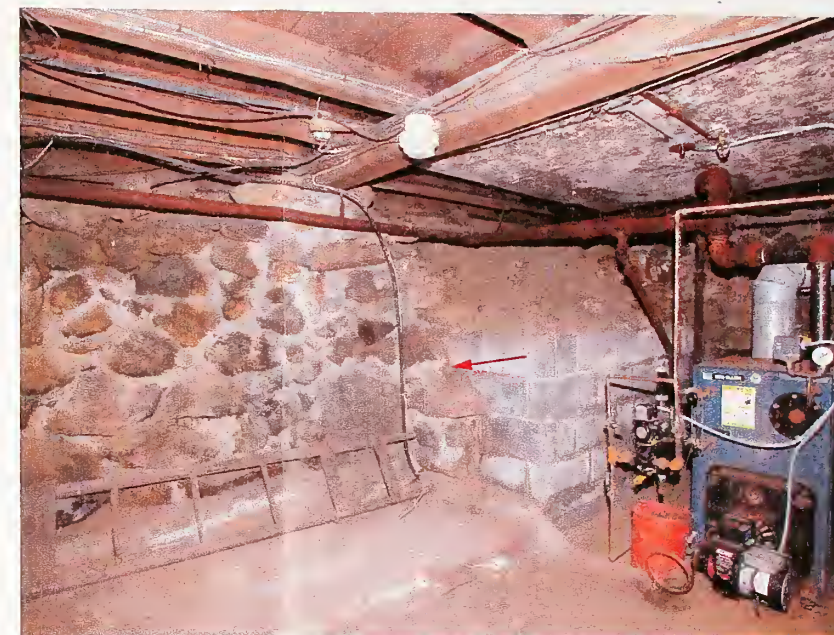
16.4: East (hall) basement looking at fireplace foundation. This was a half basement until the mid 20th century when the rear section was dug out, the fireplace foundation retained by a new cement block wall, most of the foundation pointed with cement mortar, and a cement floor added. The return of the stone wall marked with an arrow was the original back wall of this cellar. The existing joists are vertically sawn and of unknown age, but probably not original. The center beam is a 20th century addition.
